### Inspection Report

#### Minerals Regulatory Program

**Mine Name:** Skull Valley Diatomaceous Earth

**Permit number:** M/045/060

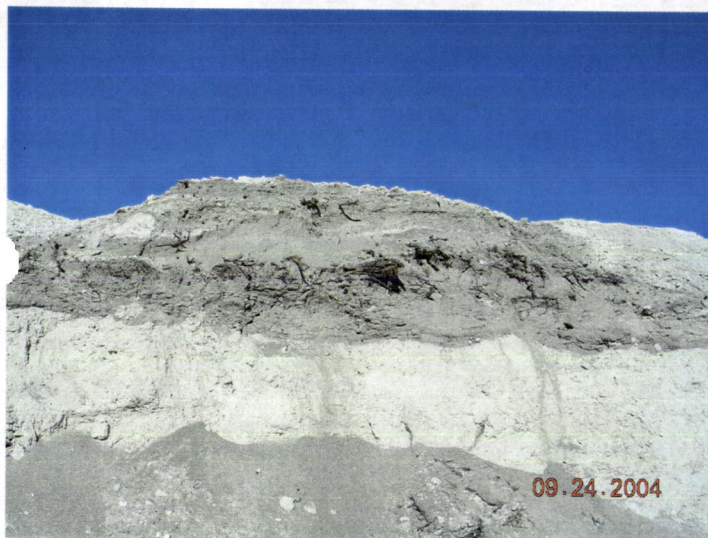
Photo 1 was taken within the disturbed area, but I believe it shows some undisturbed soil and a very clear, sharp demarcation between the soil and underlying layers. The surface soil appears to have more sand than the soil used in reclamation.

I did not get a good picture of the material being salvaged as topsoil, but it appears to include both the darker, sandier material from the surface and some silty material from below.

**Photo 1. A soil lens on the edge of the area being mined.**

Based on this inspection, I feel more strongly than ever that the plan needs to contain baseline soils information, especially considering the lack of revegetation success.

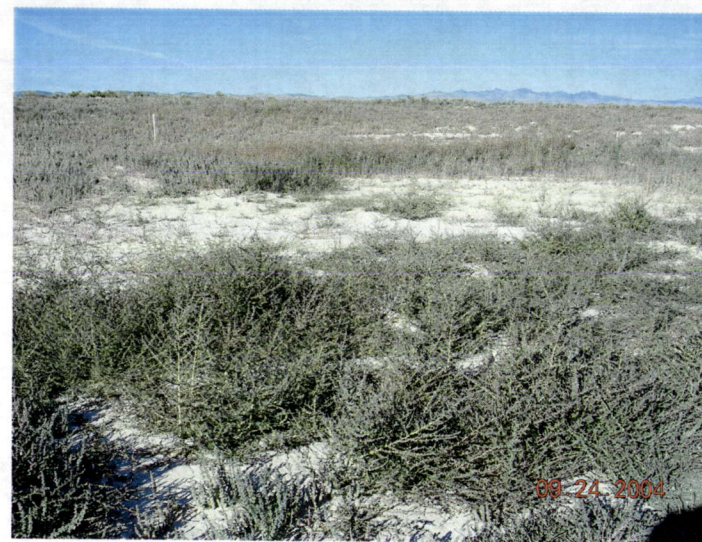
Vegetation in the reclaimed area appears to be 100 percent halogeton, Russian thistle, and kochia (Photo 2). The kochia tended to be in the bottom of the pit (Photo 3). I saw no desirable plants at all. There are several factors that could have contributed to this, including failure to plant seed, poor quality seed, poor timing of the seeding, bad weather conditions, lack of surface roughening, and poor quality soils.

**Photo 3. *Kochia scoparia* in the bottom of the pit.**

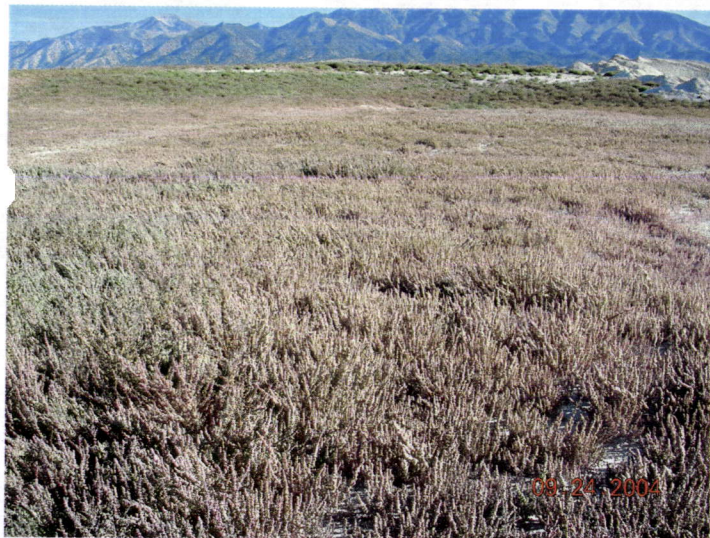
**Photo 2. The reclaimed area. Vegetation in the foreground is halogeton, and the greener plants in the background are mostly Russian thistle.**

The operator needs to do everything possible to maximize the chances for revegetation success at this difficult site. These include making sure the right soils are harvested and put back, planting in the fall and at no other time, using good quality seed from a reputable dealer, and keeping the surface very rough. Considering the nature of the soil, keeping a rough surface may be difficult, but it is very important.

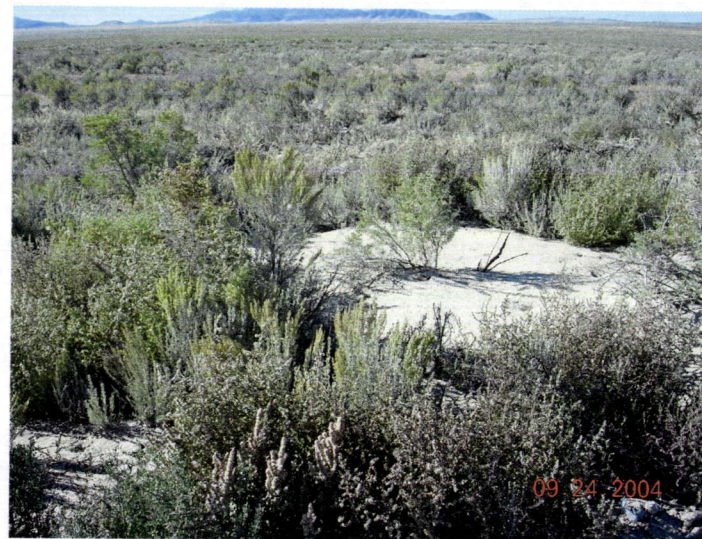
Adjacent undisturbed areas also had a lot of halogeton, kochia, and Russian thistle, but sagebrush and greasewood were dominant (Photo 4).

**Photo 4. Vegetation in the adjacent undisturbed area. It is mostly sagebrush with greasewood, halogeton, cheatgrass, and Russian thistle.**

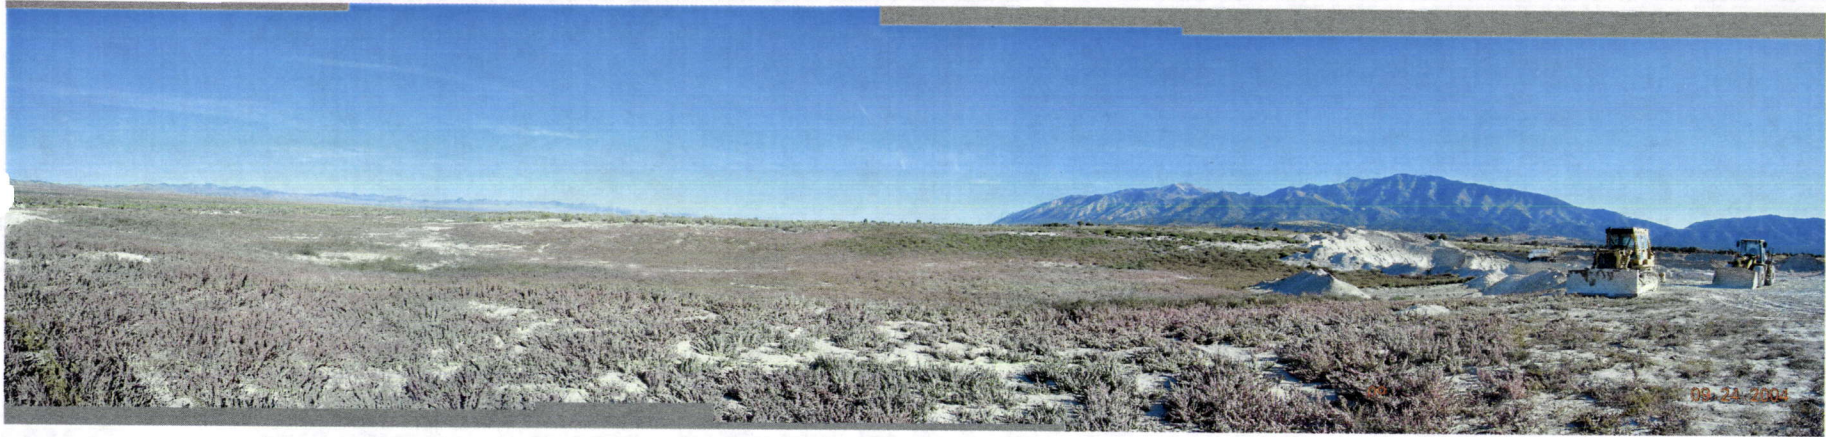
**Photo 5. Panorama of the reclaimed and active mining areas.**
